## **2-D analysis of a building frame under gravity load and fire**

Dat Duthinh<sup>1</sup>

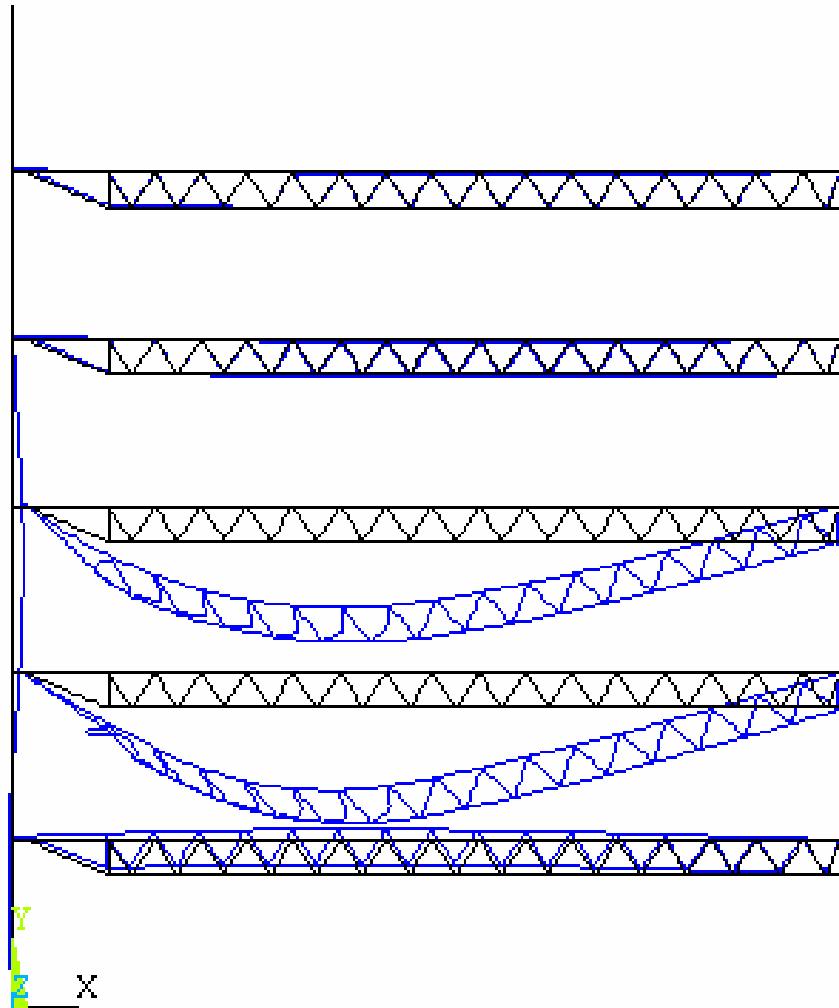
Fig. 1 Deformed shape at 1273°K

Nonlinear, static, large deformation analysis accounting for P-delta effects and buckling was performed. The analysis proceeded in a number of load steps, the first corresponding to gravity loads at the start of the fire (normal room temperature). Subsequent steps occurred at 200 s intervals, with the maximum temperature attained, to within 1°K, at 1400 s. Results are shown in Figs. 1-3.

For comparison with Quintiere et al. [3], our results show that the truss diagonals buckle *inelastically*, and there is considerable reserve strength after the first diagonal buckles. At the highest temperatures analyzed, seven diagonals and vertical had buckled in each of the heated floors. This conclusion assumes that the various structural connections maintain their integrity throughout the fire.

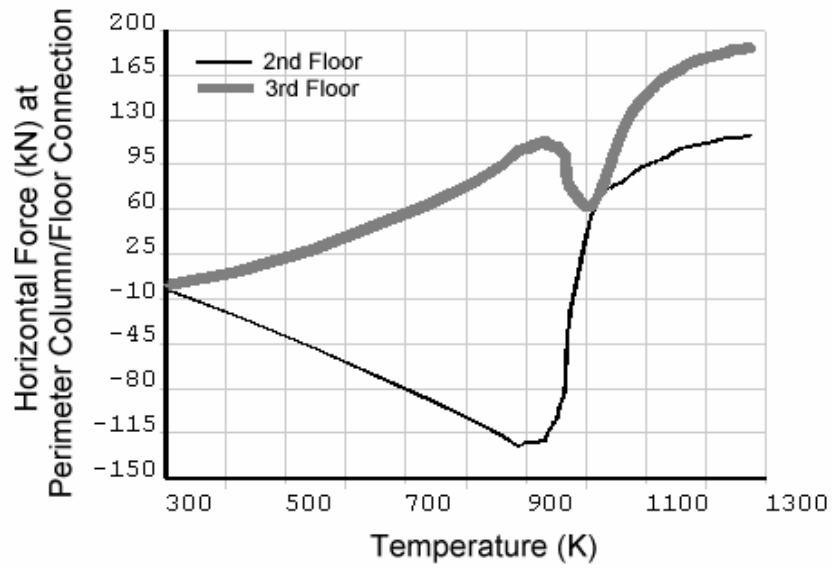
Fig. 2 Horizontal force (kN) between column and second and third floors vs. temperature ( $^{\circ}$ K)

At room temperature, even under the severe load redistribution due to initial damage to the building, non-linear effects are negligible, i.e., the structure still behaves linearly. The maximum floor sag is 35 mm (1.4 in), causing the horizontal span to decrease and the column to pull in slightly. Approaching 200 s and a temperature of 915°K, the heated trusses begin to show distress, especially in the compressed diagonal and vertical members, which buckle inelastically. (The temperatures referred to in these results are the hottest temperatures in the structure at any given time.) At 200 s the maximum floor sag increases to 335 mm (13.2 in), and the column is pushed out (peak of 38 mm or 1.5 in) by the thermal expansion of the second floor. At that time the connection of the second floor to the perimeter column experiences its maximum compression of 125 kN (28 kips). Because the third floor slab has a thermal gradient with its top surface at room temperature, its lateral expansion is much smaller than for the second floor slab, and its sag is larger. The connection between the third floor slab and the column is always in tension (Fig. 2). As expected, the bottom floor slab, heated at the top and cool at the bottom, bows upward. As the temperature continues to rise, more of the second floor truss fails, and the increasing sag begins to pull the column in. The horizontal deflection of the column becomes positive (inward), and the connection force between the column and the second floor turns to tension. This inward movement of the column relieves the tension in the connection between the column and the third floor. Further temperature rise causes further weakening in the third floor truss, which eventually becomes active in pulling the column in. At the peak temperature of 1273°K, the maximum lateral deflection in the column (183 mm or 3.3 in) occurs at the third floor, inward, and the connection between the column and the third floor experiences a tension of 185 kN (41.6 kips). The connection forces supplied by the interior column to the floors are similar to that of the external column.

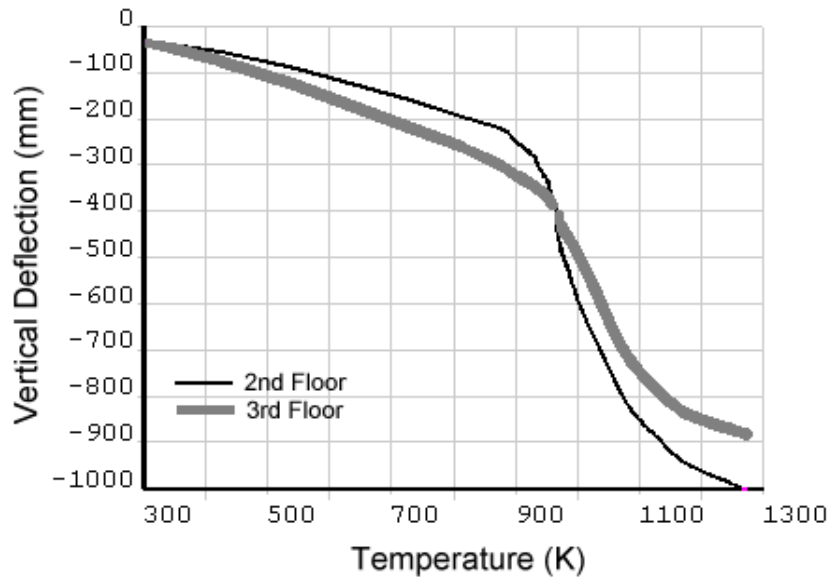
Fig. 3 Vertical deflections (mm) of second and third floors vs. temperature ( $^{\circ}$ K)
